Applying Infrared Imaging Techniques to Marine Surveying

InfraMation 2003 Application Paper Submission

John (JACK) N. Allinson

J.N. Allinson Associates, Inc.

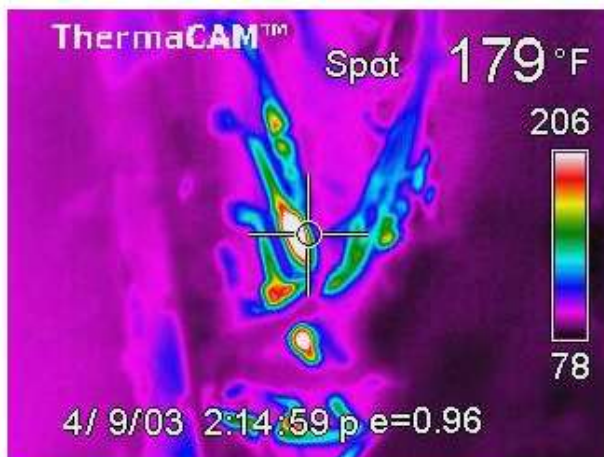
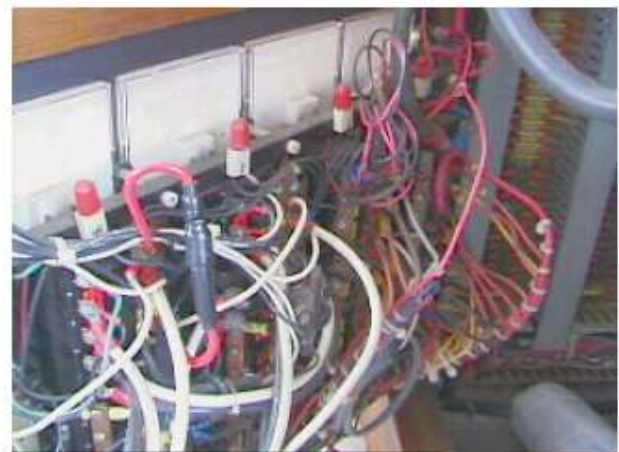
Figure 1. This is the back of an electric distribution panel in a 40-foot boat. Visual inspection shows that the wires are intact, wire insulation and terminals were free of burn or scorch marks. Infrared view shows that one of the wires in the bundle of wires is much hotter than the others. The heat and resistance in this wire caused its magnetic circuit breaker to trip intermittently.

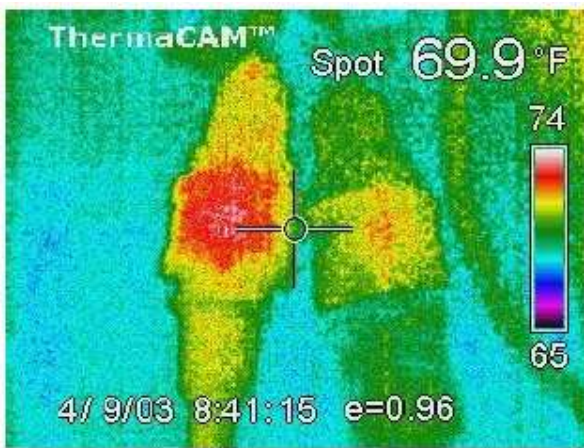
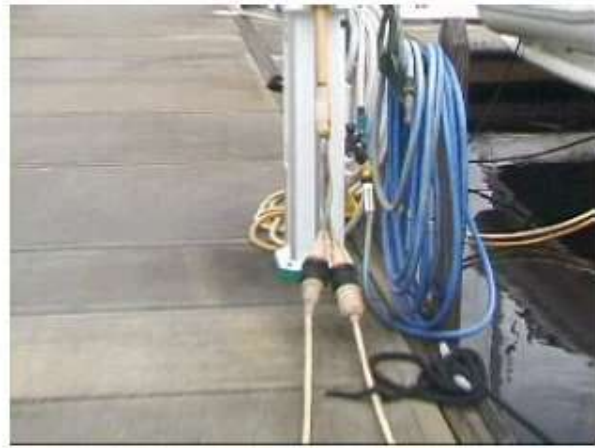
Figure 2. This is a power pedestal on a dock that supplies electric power (shore power) to a boat. A single 50 amp 220vAC shore power cord (light yellow) splits into two (2) 30 amp 110 VAC feeds. This item is known as a "Y adapter" and commonly used for boats that have two (2) 30 amp 120 VAC inlets. There is electrical resistance building up on the left leg of the "Y adapter" and it should be scheduled to be replaced.

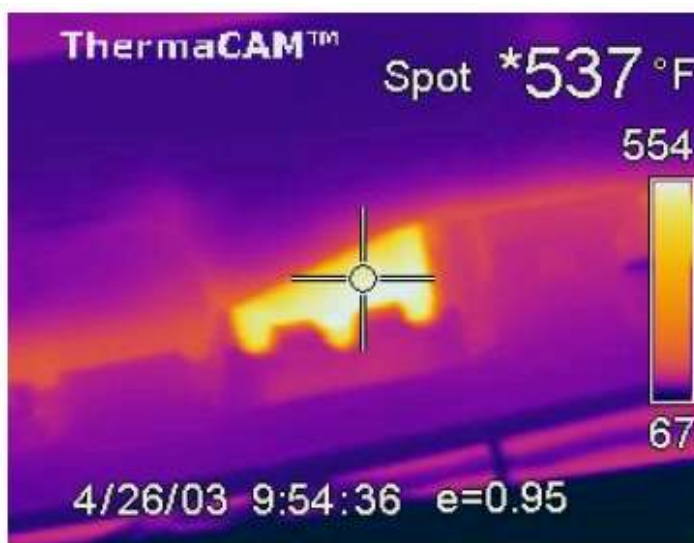
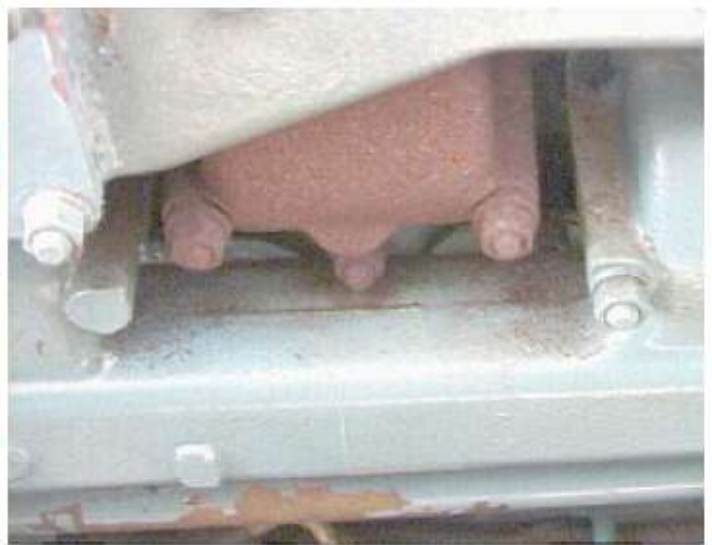
Figure 3. Views of a portion of an exhaust manifold for a 160 hp 6 cylinder turbocharged diesel engine. During the sea trial, the engine overheated. A thermal image of one of the exhaust ports on the manifold showed excessive temperature. Buyer advised to have a marine mechanic examine the turbocharger system.

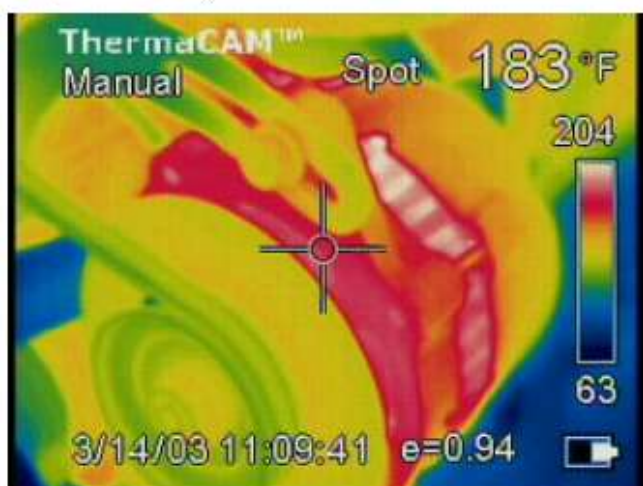
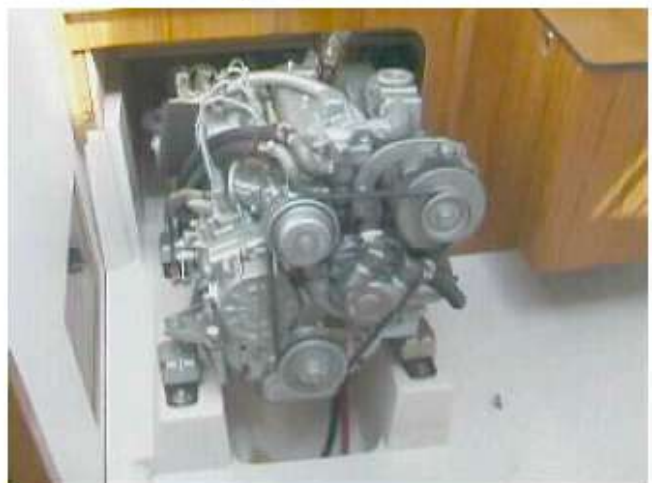
Figure 4. Views of a 3-cylinder naturally aspirating diesel engine. Visual photograph (right) shows the engine with a factory installed low amperage output 12VDC alternator. Owner replaced original "wet cell" battery bank to one with a larger capacity. The new battery bank was much too large to be effectively charged by the factory installed alternator. There were no visual signs that the alternator was being overworked, however the battery bank would never get fully charged and batteries suffered from sulfation. Infrared showed windings in alternator were hotter than expected. This visual evidence coupled with measuring low input voltage at the battery terminals solidified the recommendation why the buyer should upgrade to a higher amperage output alternator.

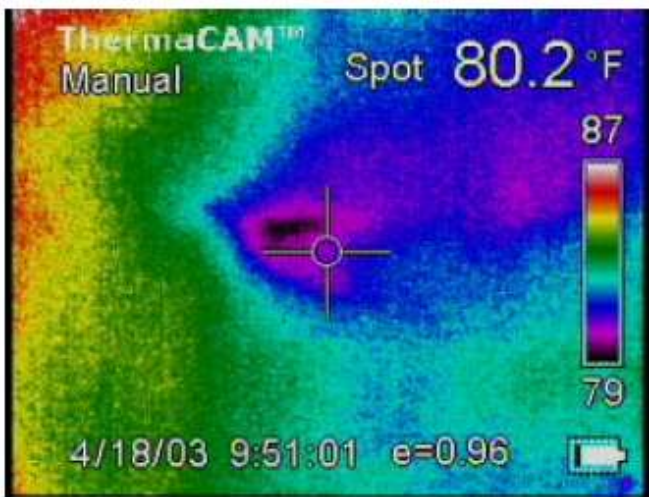
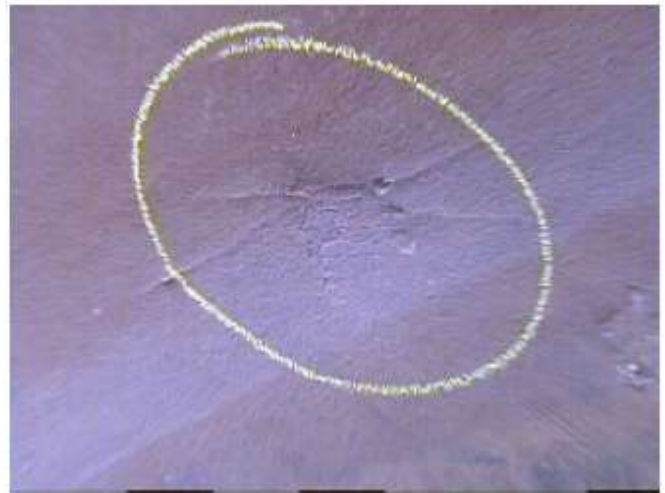
Figure 5. The area circled in yellow shows an unusual indentation in the hull of a boat constructed with FRP. Area visually appears dry. Infrared image shows cooler temperature, revealing moisture intrusion in this portion of the hull.

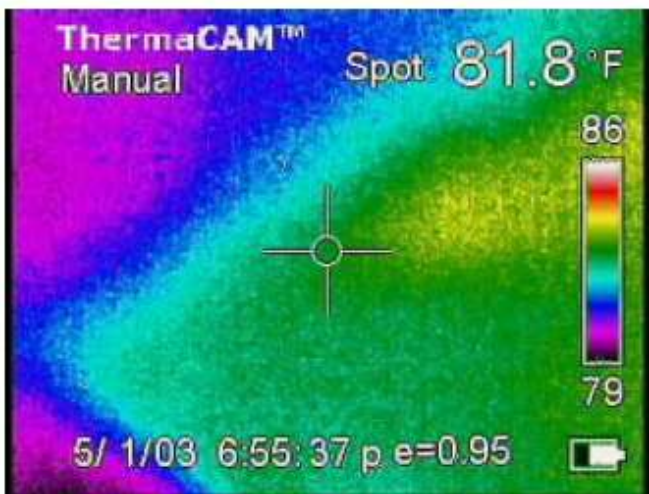
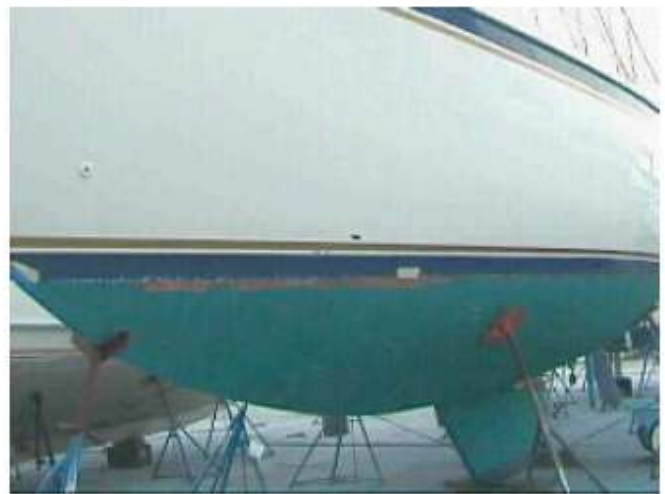
Figure 6. This is the side of a sailboat constructed with FRP. The sailboat sustained impact damage and there was a faint visual sign of delamination. The infrared image shows warmer temperatures, revealing the extent and pattern of delamination in the FRP.

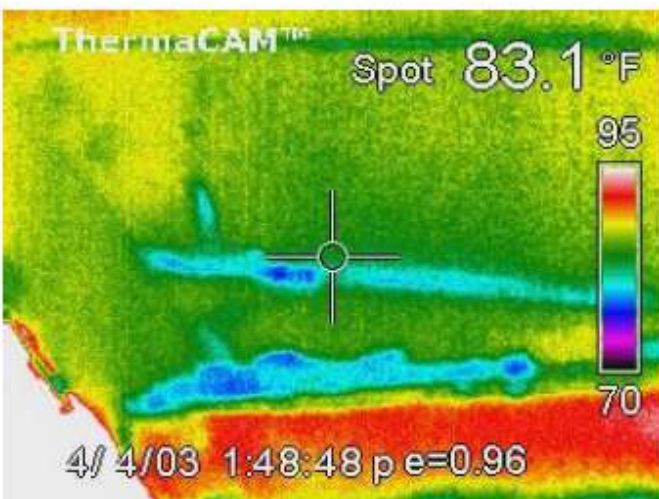
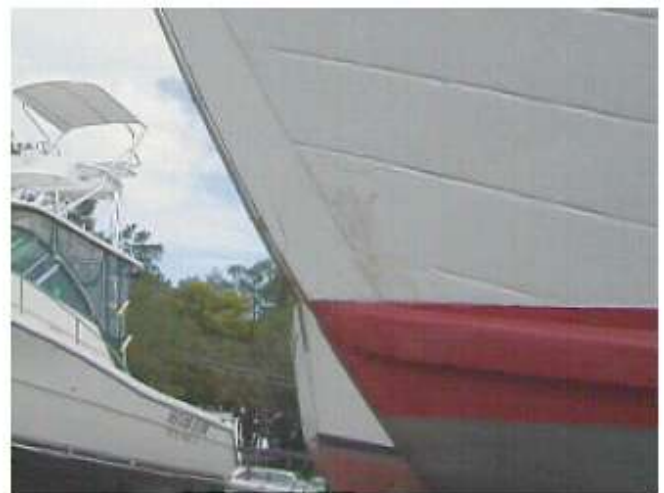
Figure 7. Views of the bow of a boat hull constructed of wooden planks. Routine maintenance involves caulking the seams between the wooden planks to prevent moisture intrusion. The infrared image confirms that caulking is needed as it shows cooler areas where moisture has entered into seams.

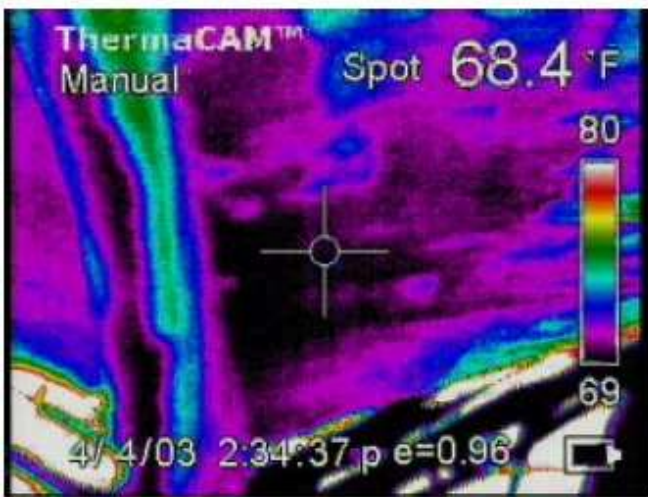
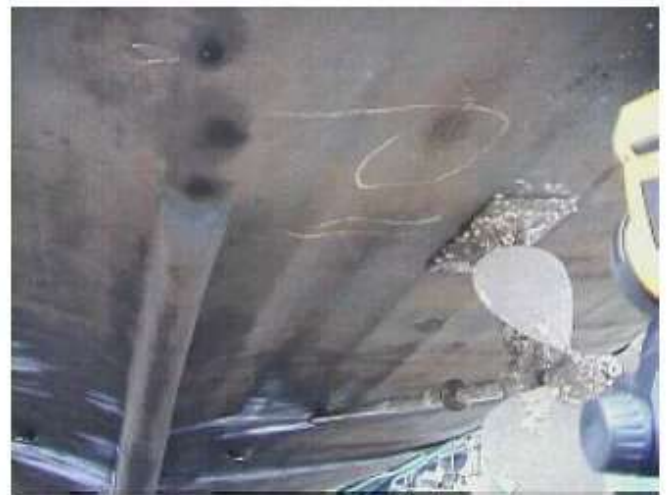
Figure 8. A common practice to extend the life of the bottom of a wooden boat is to sheath it in FRP. It is used to reduce maintenance and prevent marine organisms (e.g., Terado worms) from boring into the wood. Sometimes the physical bond between the wood and FRP breaks down, and water gets trapped in the interstitial space. The wood continues to decay and the FRP disbonds from the wood. Coolness in the infrared image shows the extent of water entrapment and disbonding that can be heard when sounding the hull with a percussion hammer.

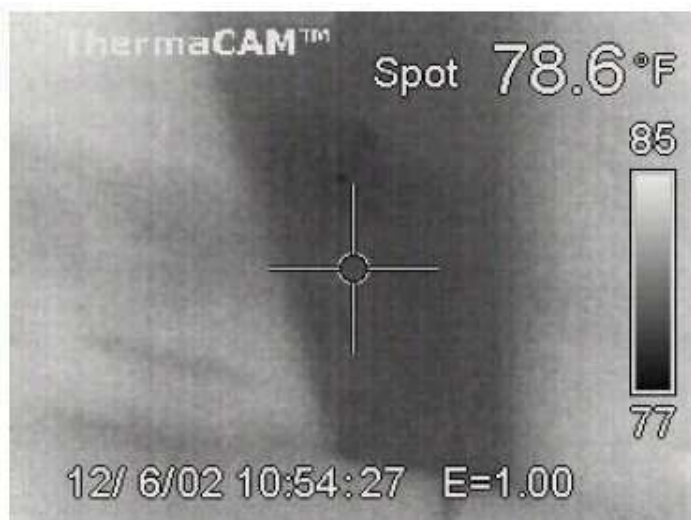
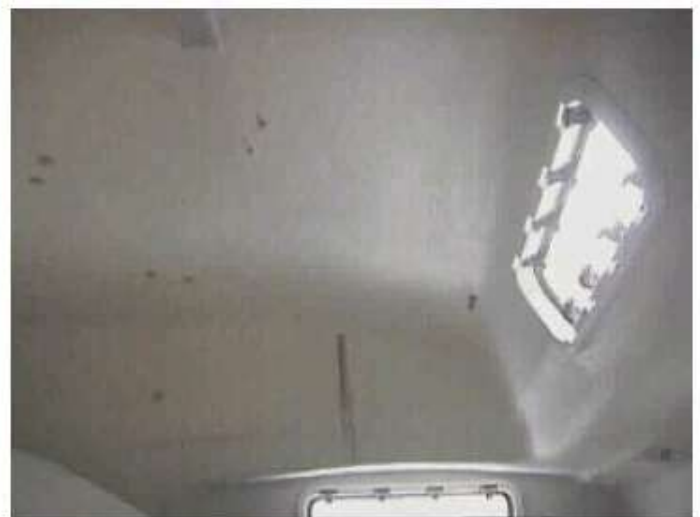
Figure 9. This is the interior ceiling of a FRP constructed catamaran sailboat. Brown fluid observed running out down the ceiling wall visually shows there is a problem with water intrusion. The ceiling is a sandwich construction composite of an outer skin of FRP, an intermediate core of wood, and an inner skin of FRP. The black and white pallet infrared image (left) shows the extent of moisture intrusion.

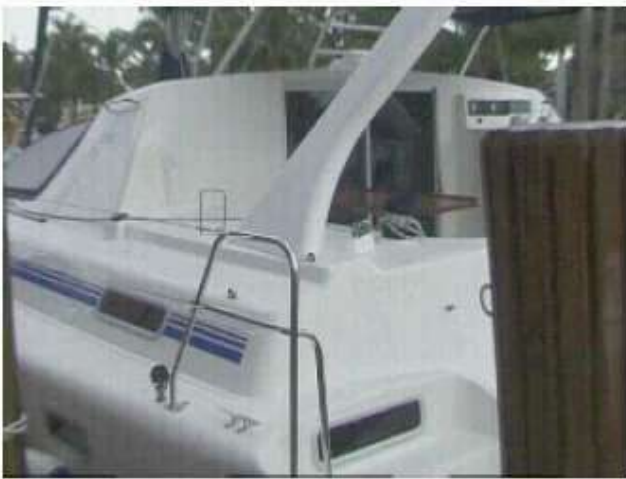
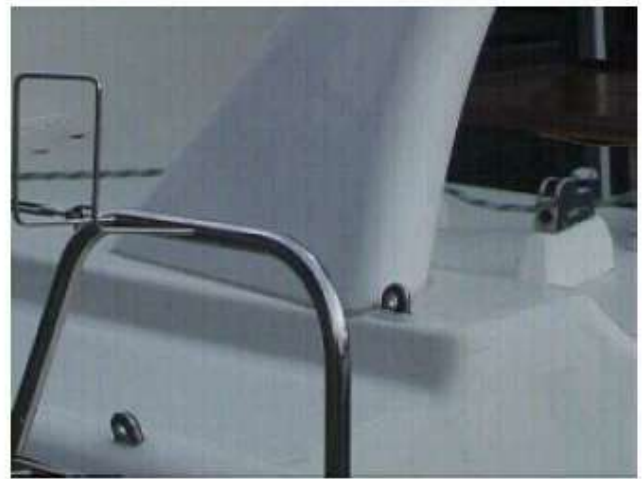
Figure 10. On deck photos of the sailing catamaran shows the exterior side corresponding to the interior ceiling. Note the raised deck in the FRP construction. It is common practice to use a composite construction to reduce the weight of the boat. In this case the composite is FRP/wood/FRP. If the raised deck area were constructed with a solid FRP laminate, it would be much heavier and cost more to construct. A lighter boat sails faster than a heavier boat.
