## Costs saving in maintenance by expanding the use of thermographic imaging.

## 1. Expanding to mechanical & operational components:

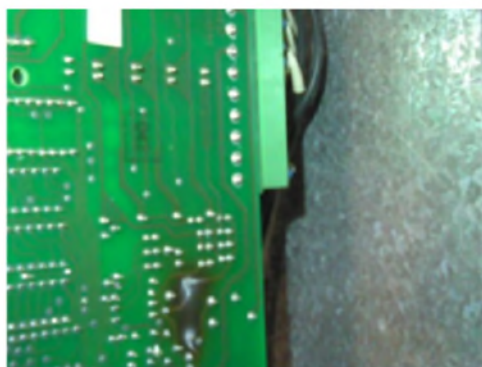
FLIR0262.jpg | 289° W

Spots	-
Lines	-
Bx1 Average	69,8 °C
Bx1 Maximum	116,3 °C
Bx1 Minimum	37,8 °C
Bx1 Area	0,0 m <sup>2</sup>
Ellipses	-
Deltas	-

Parameters	
Emissivity	0,95
Reflected temperature	20,0 °C
Distance	2,0 m
Atmospheric temperature	15,0 °C
Relative humidity	60%
External optics temperature	20,0 °C
External optics transmission	1,00

Component on stabilizer card "A201" was found to be overheating, already showing black marking and signs of decay. Similar card was found in stock at the warehouse and flown in with the first helicopter. FU notif 1100186258 was made and card has been replaced.

Subsequent thermal inspection shows the new card is performing within limits.

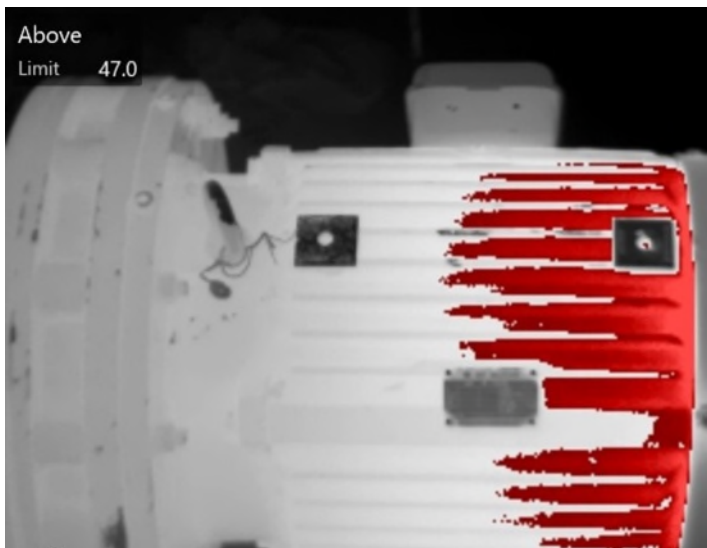
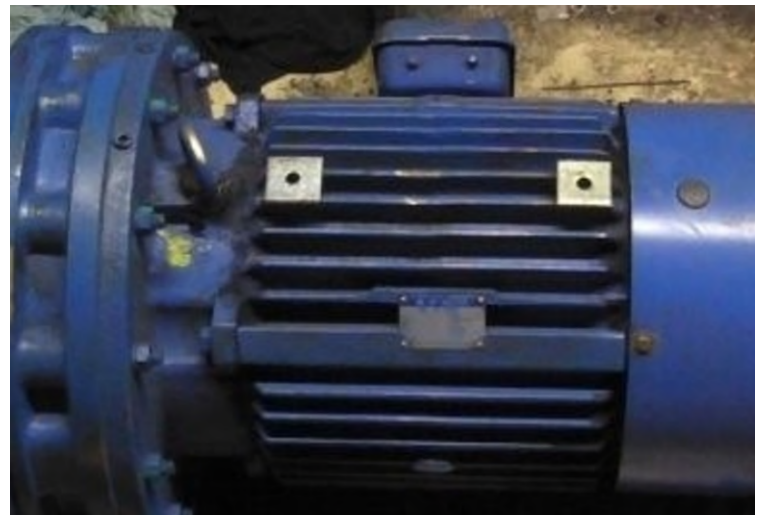
- Brake gap set incorrectly, causing excess drag on motor.
- Visible only by analyzing the thermal profile.

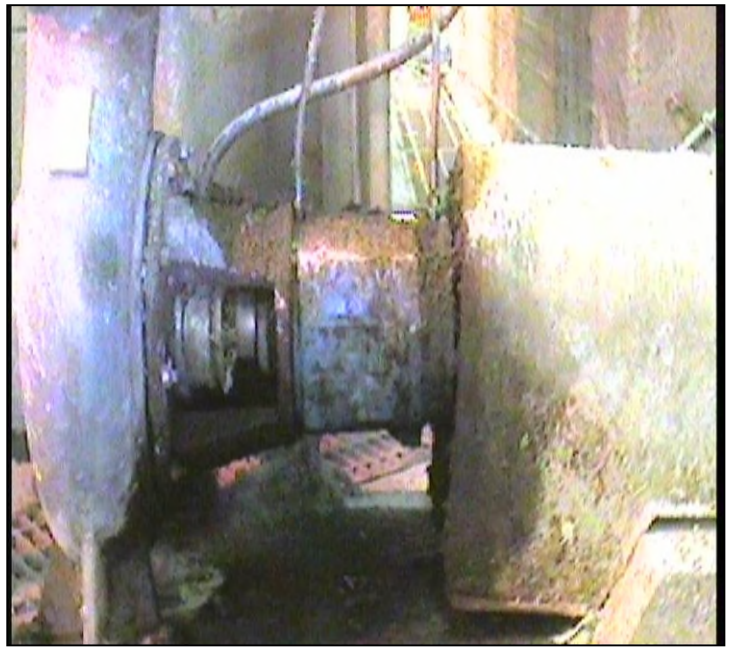
- Bearing heating up, possibly insufficient lubrication or alignment problem.

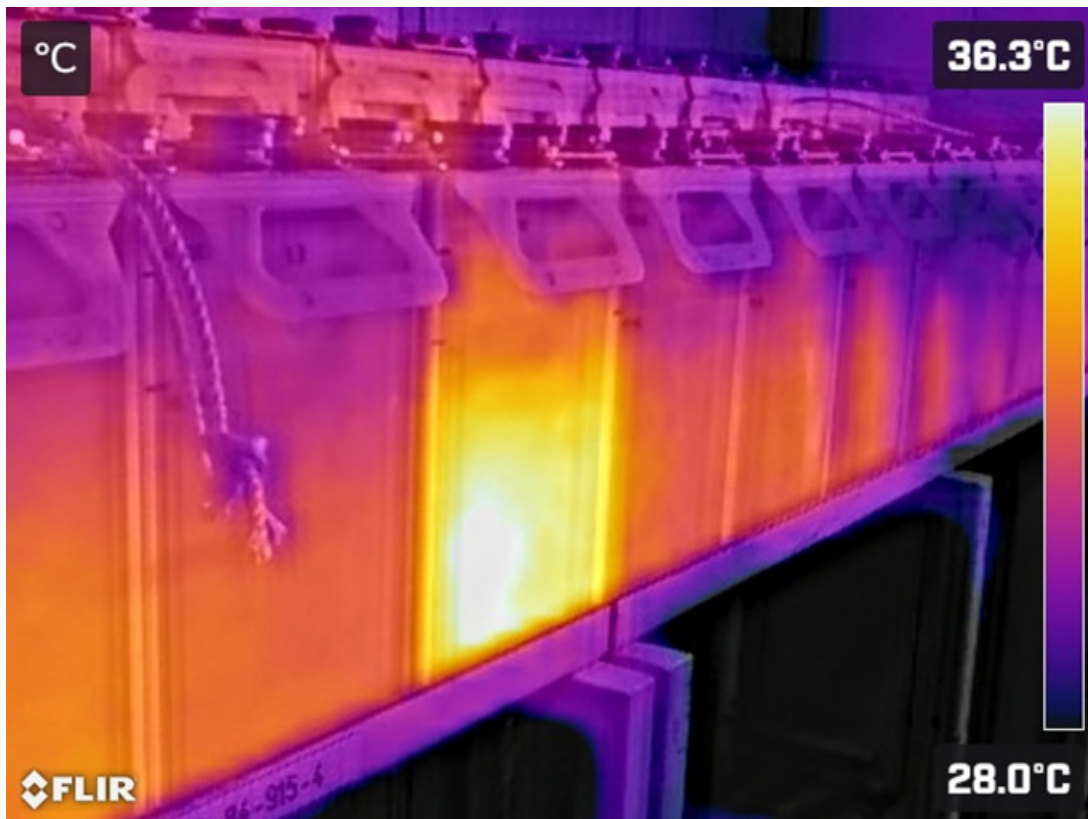
- Increased resistance inside Ni-Cd battery cell during charging. Possible bad cell.
